# Manhole Inspection Summary

Manhole # S25I\_\_031MH

Insp Date: **3/17/08 12:43 PM**

**Location** Address: **34 S.CAREY ST.**

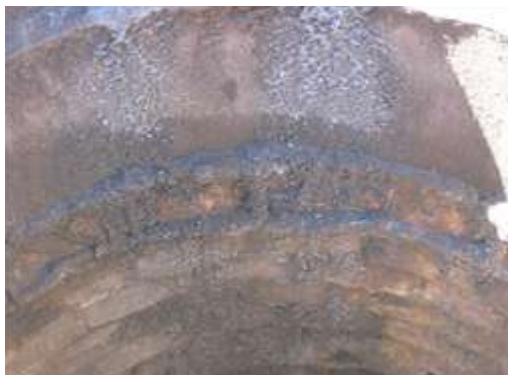
Deposits on chimney & corbel

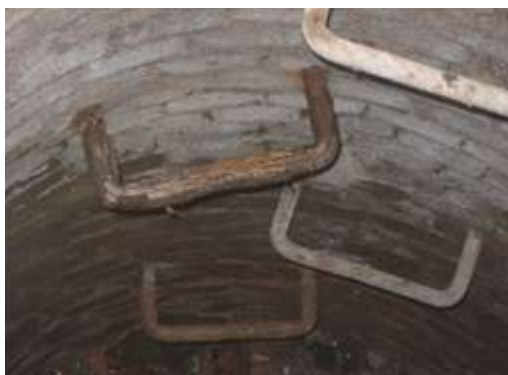
Defect 3

CORRODED STEPS AND EVIDENCE OF INFILTRATION AT THE BARREL

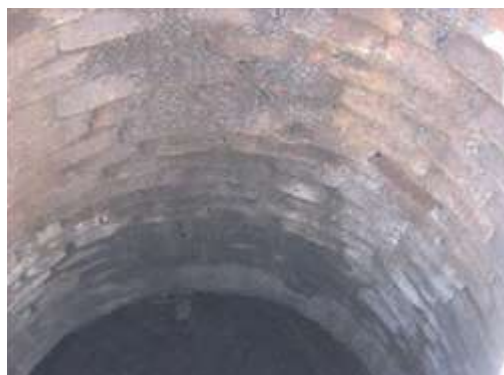
Defect 2

INFILTRATION AT CORBEL WALL

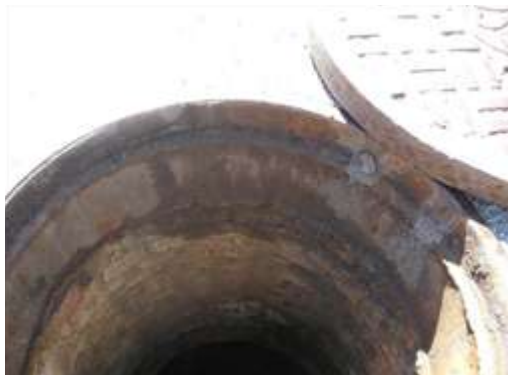
### Defect 1

MISSING MORTAR WITH EVIDENCE  
OF INFILTRATION AT THE CHIMNEY

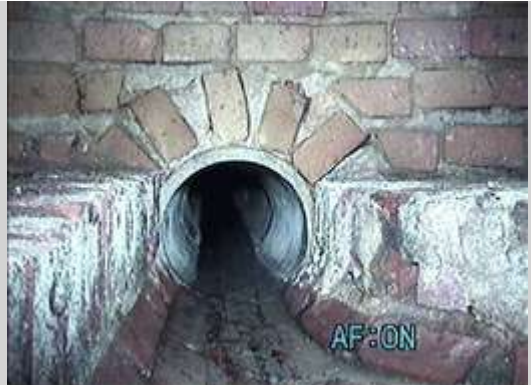
12 O'Clock Outflow

Connection not visible from above

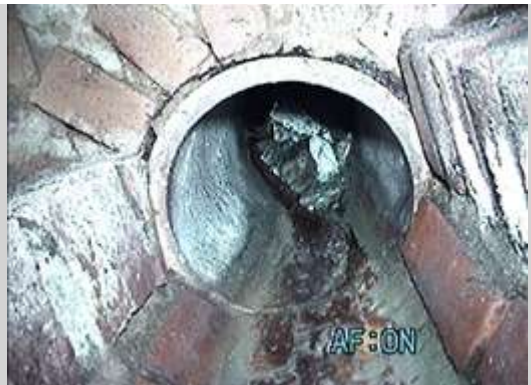
3 O'Clock Inflow

Debris in incoming pipe; Connection not visible from above
